# **BRITE DECKING (PTY) PTY LTD.**

## **TEST REPORT**

AS 1530.8.1:2018 TESTING ON "TITANIUM" BETTER WOOD, MODEL D140-T24

201118005SHF-001

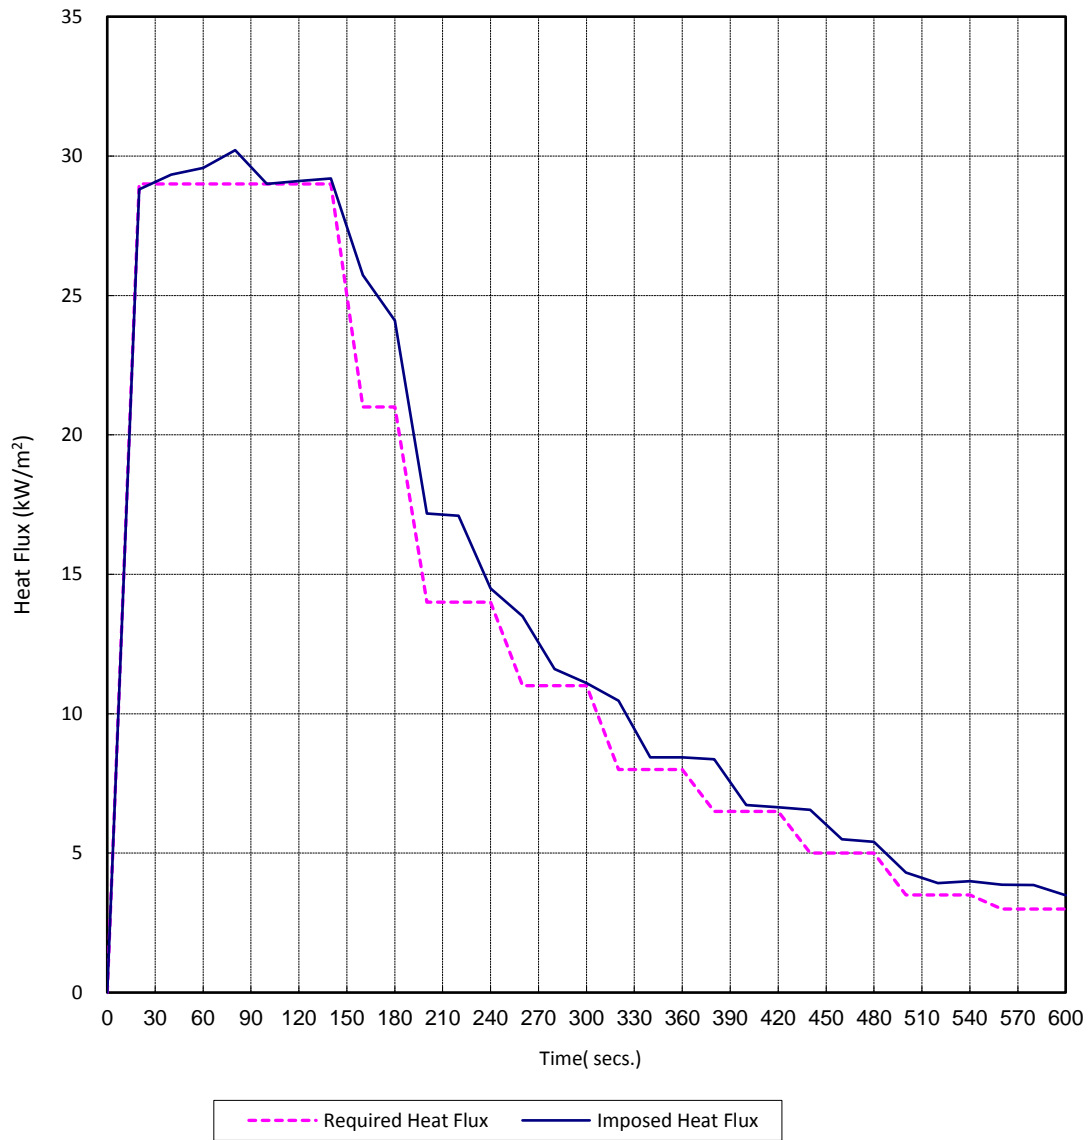
### Graph for imposed heat flux and heat flux profiles specified in the standard

Time/ Secs	Specified Heat Flux/ kW/m <sup>2</sup>	Incident Heat Flux / kW/m <sup>2</sup>
0	0	0.0
20	29	28.8
40	29	29.3
60	29	29.6
80	29	30.2
100	29	29.0
120	29	29.1
140	29	29.2
160	21	25.7
180	21	24.1
200	14	17.2
220	14	17.1
240	14	14.5
260	11	13.5
280	11	11.6
300	11	11.1
320	8	10.5
340	8	8.4
360	8	8.4
380	6.5	8.4
400	6.5	6.7
420	6.5	6.6
440	5	6.6
460	5	5.5
480	5	5.4
500	3.5	4.3
520	3.5	3.9
540	3.5	4.0
560	3	3.9
580	3	3.9
600	3	3.5

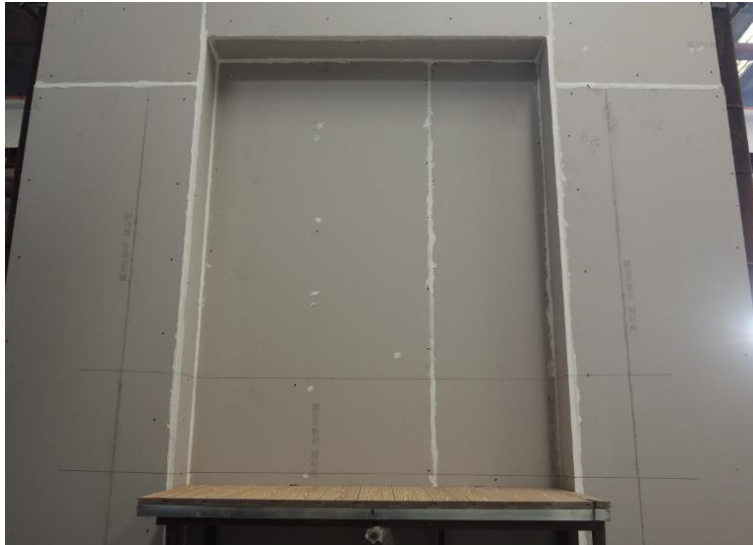
Fig. 1 Exposed Side Prior to the radiant heat test

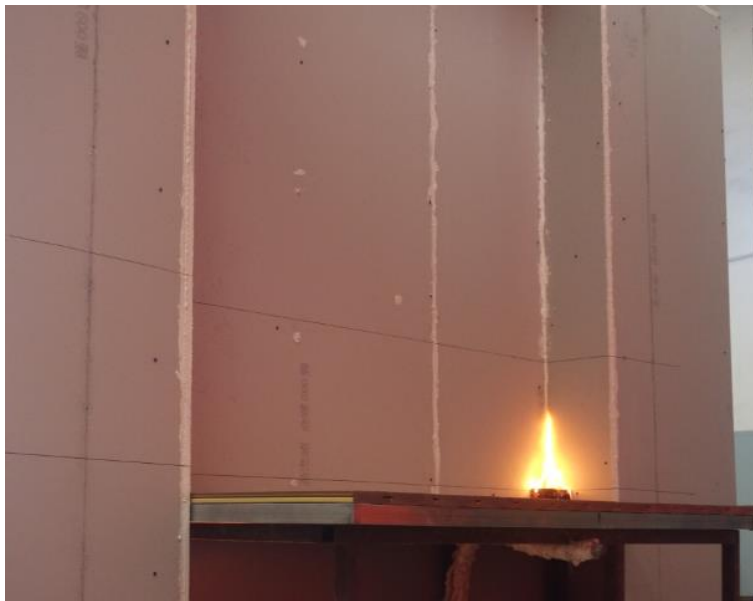
Fig. 2 Exposed Side during the radiant heat test

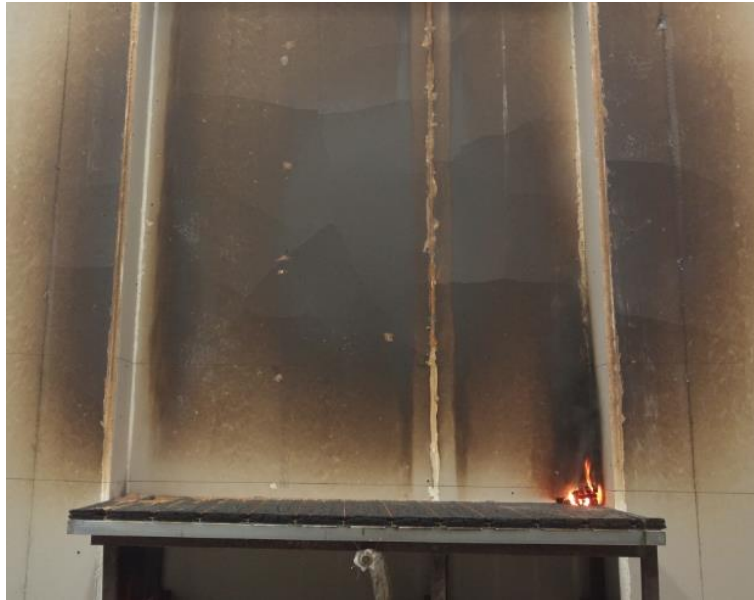
Fig. 3 Exposed Side after the radiant heat test

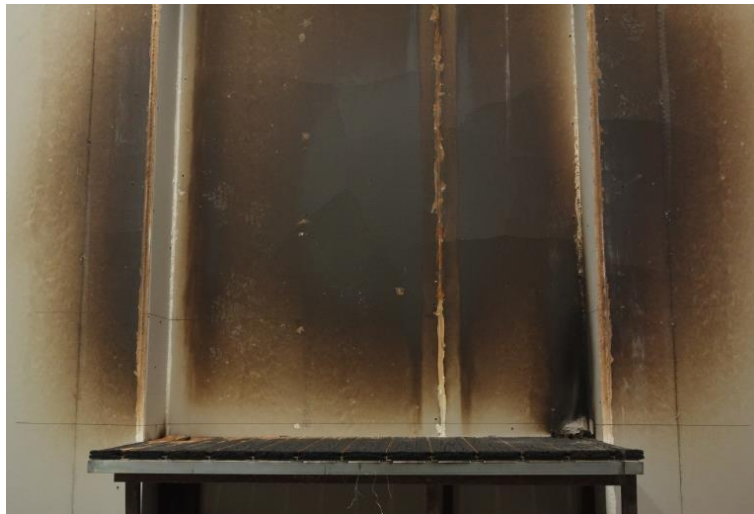
Fig. 4 Exposed Side after 60 minutes
